Technical Report

Riverside Traffic Circle Feasibility Study

July 2017

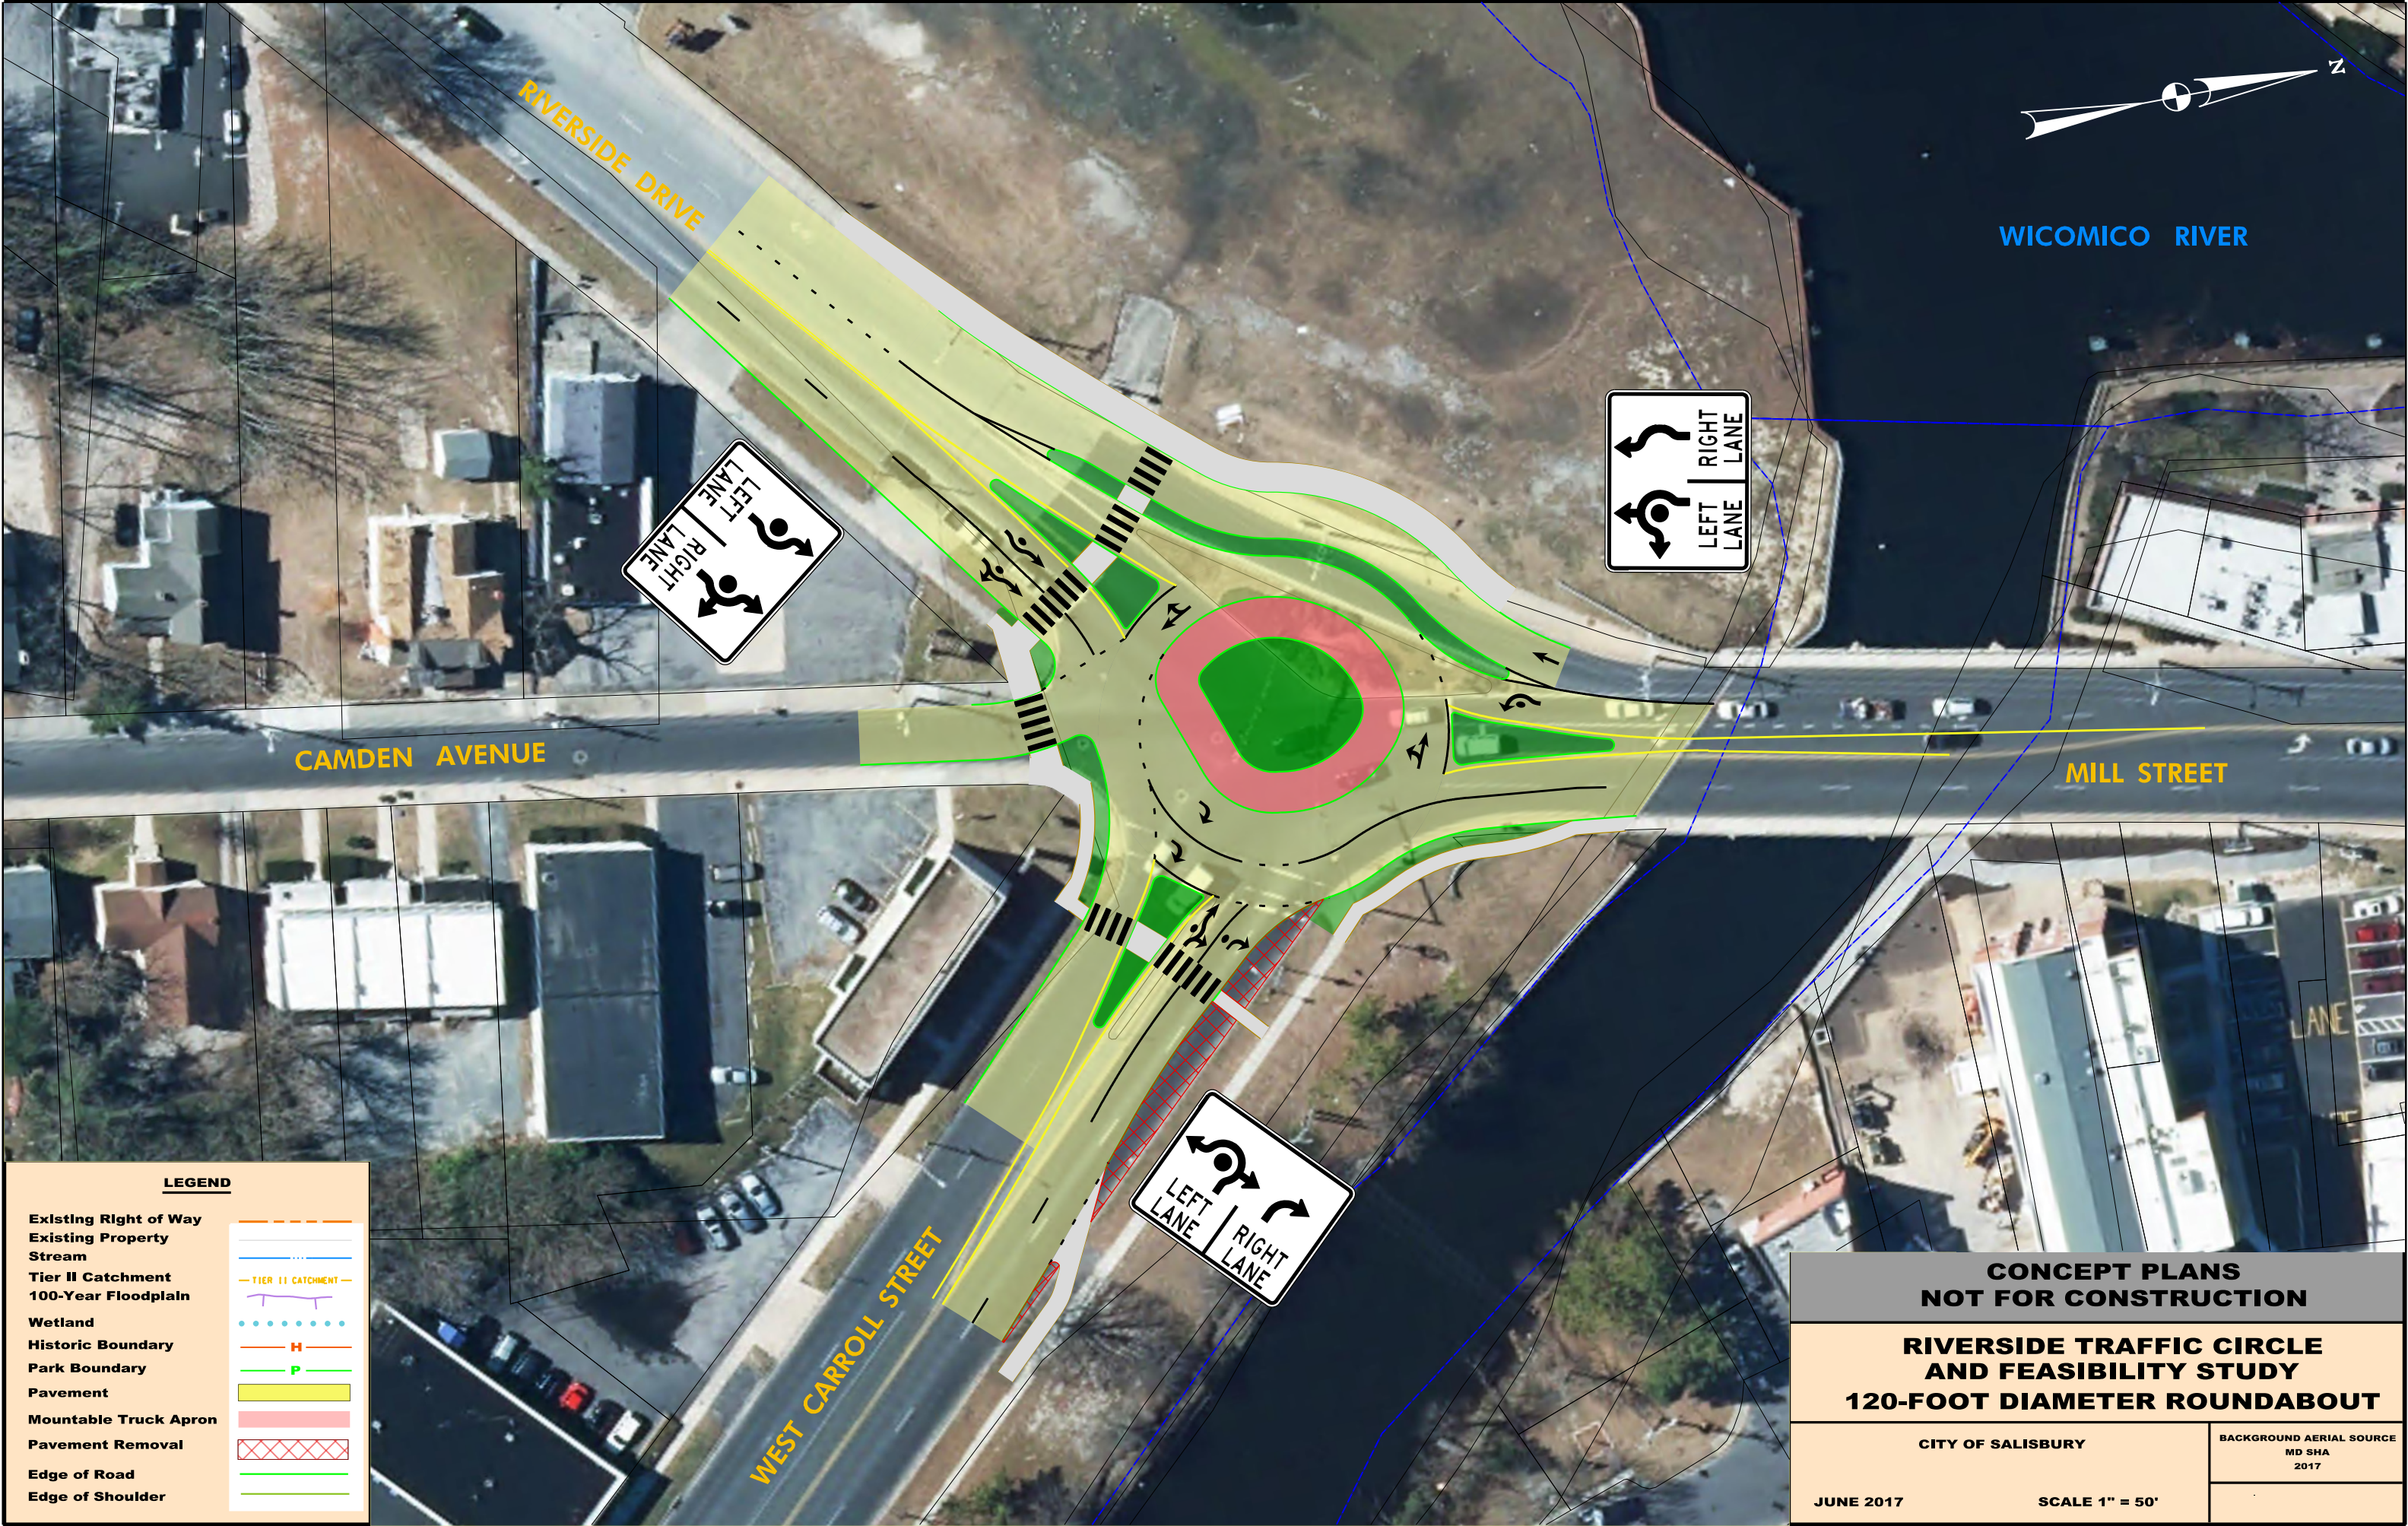
CONCEPT PLANS NOT FOR CONSTRUCTION	
RIVERSIDE TRAFFIC CIRCLE AND FEASIBILITY STUDY 120-FOOT DIAMETER ROUNDABOUT	
CITY OF SALISBURY	BACKGROUND AERIAL SOURCE MD SHA 2017
JUNE 2017	SCALE 1" = 50'

This concept proposes a multi-lane roundabout of 120-foot inscribed diameter with a bypass lane to replace the current signalized intersection. The existing bypass from Mill Street to Riverside Drive would remain in place with modifications to encourage traffic to reduce their speed to approximately 25 to 30 mph. Vehicles wishing to make any other movement would be directed to use the roundabout. Camden Avenue would remain as a one-way exit. Pedestrians would be accommodated at crossings over Riverside Drive, Camden Avenue, and West Carroll Street.

Mill Street would have a single entry lane for through movements to Camden Avenue and West Carroll Street. Riverside Drive would have two entry lanes: the left lane would be for exclusive movements to Mill Street, while the right lane would accommodate all movements. West Carroll Street would have two entry lanes: the right one would be an exclusive right onto Mill Street, while the left one would permit movements to Riverside Drive and Camden Avenue.

There is potential for conflict at the Camden Ave exit where vehicles would cross directly in front of the entrance from Riverside Drive. A careful design to encourage entering traffic to wait for vehicles exiting to Camden is required here.

A preliminary analysis of the 120-foot diameter roundabout concept revealed that the intersection would operate at the level of service shown in the table below.

Further analysis using Sidra software revealed that the volume to capacity (V/C) ratio would exceed the maximum desired value of 0.85 for all approaches during peak times by 2036. Undesirable levels would be attained by 2026 on Mill Street in the AM peak hour, and West Carroll Street in the PM peak hour. Table 8 summarizes the analysis results.

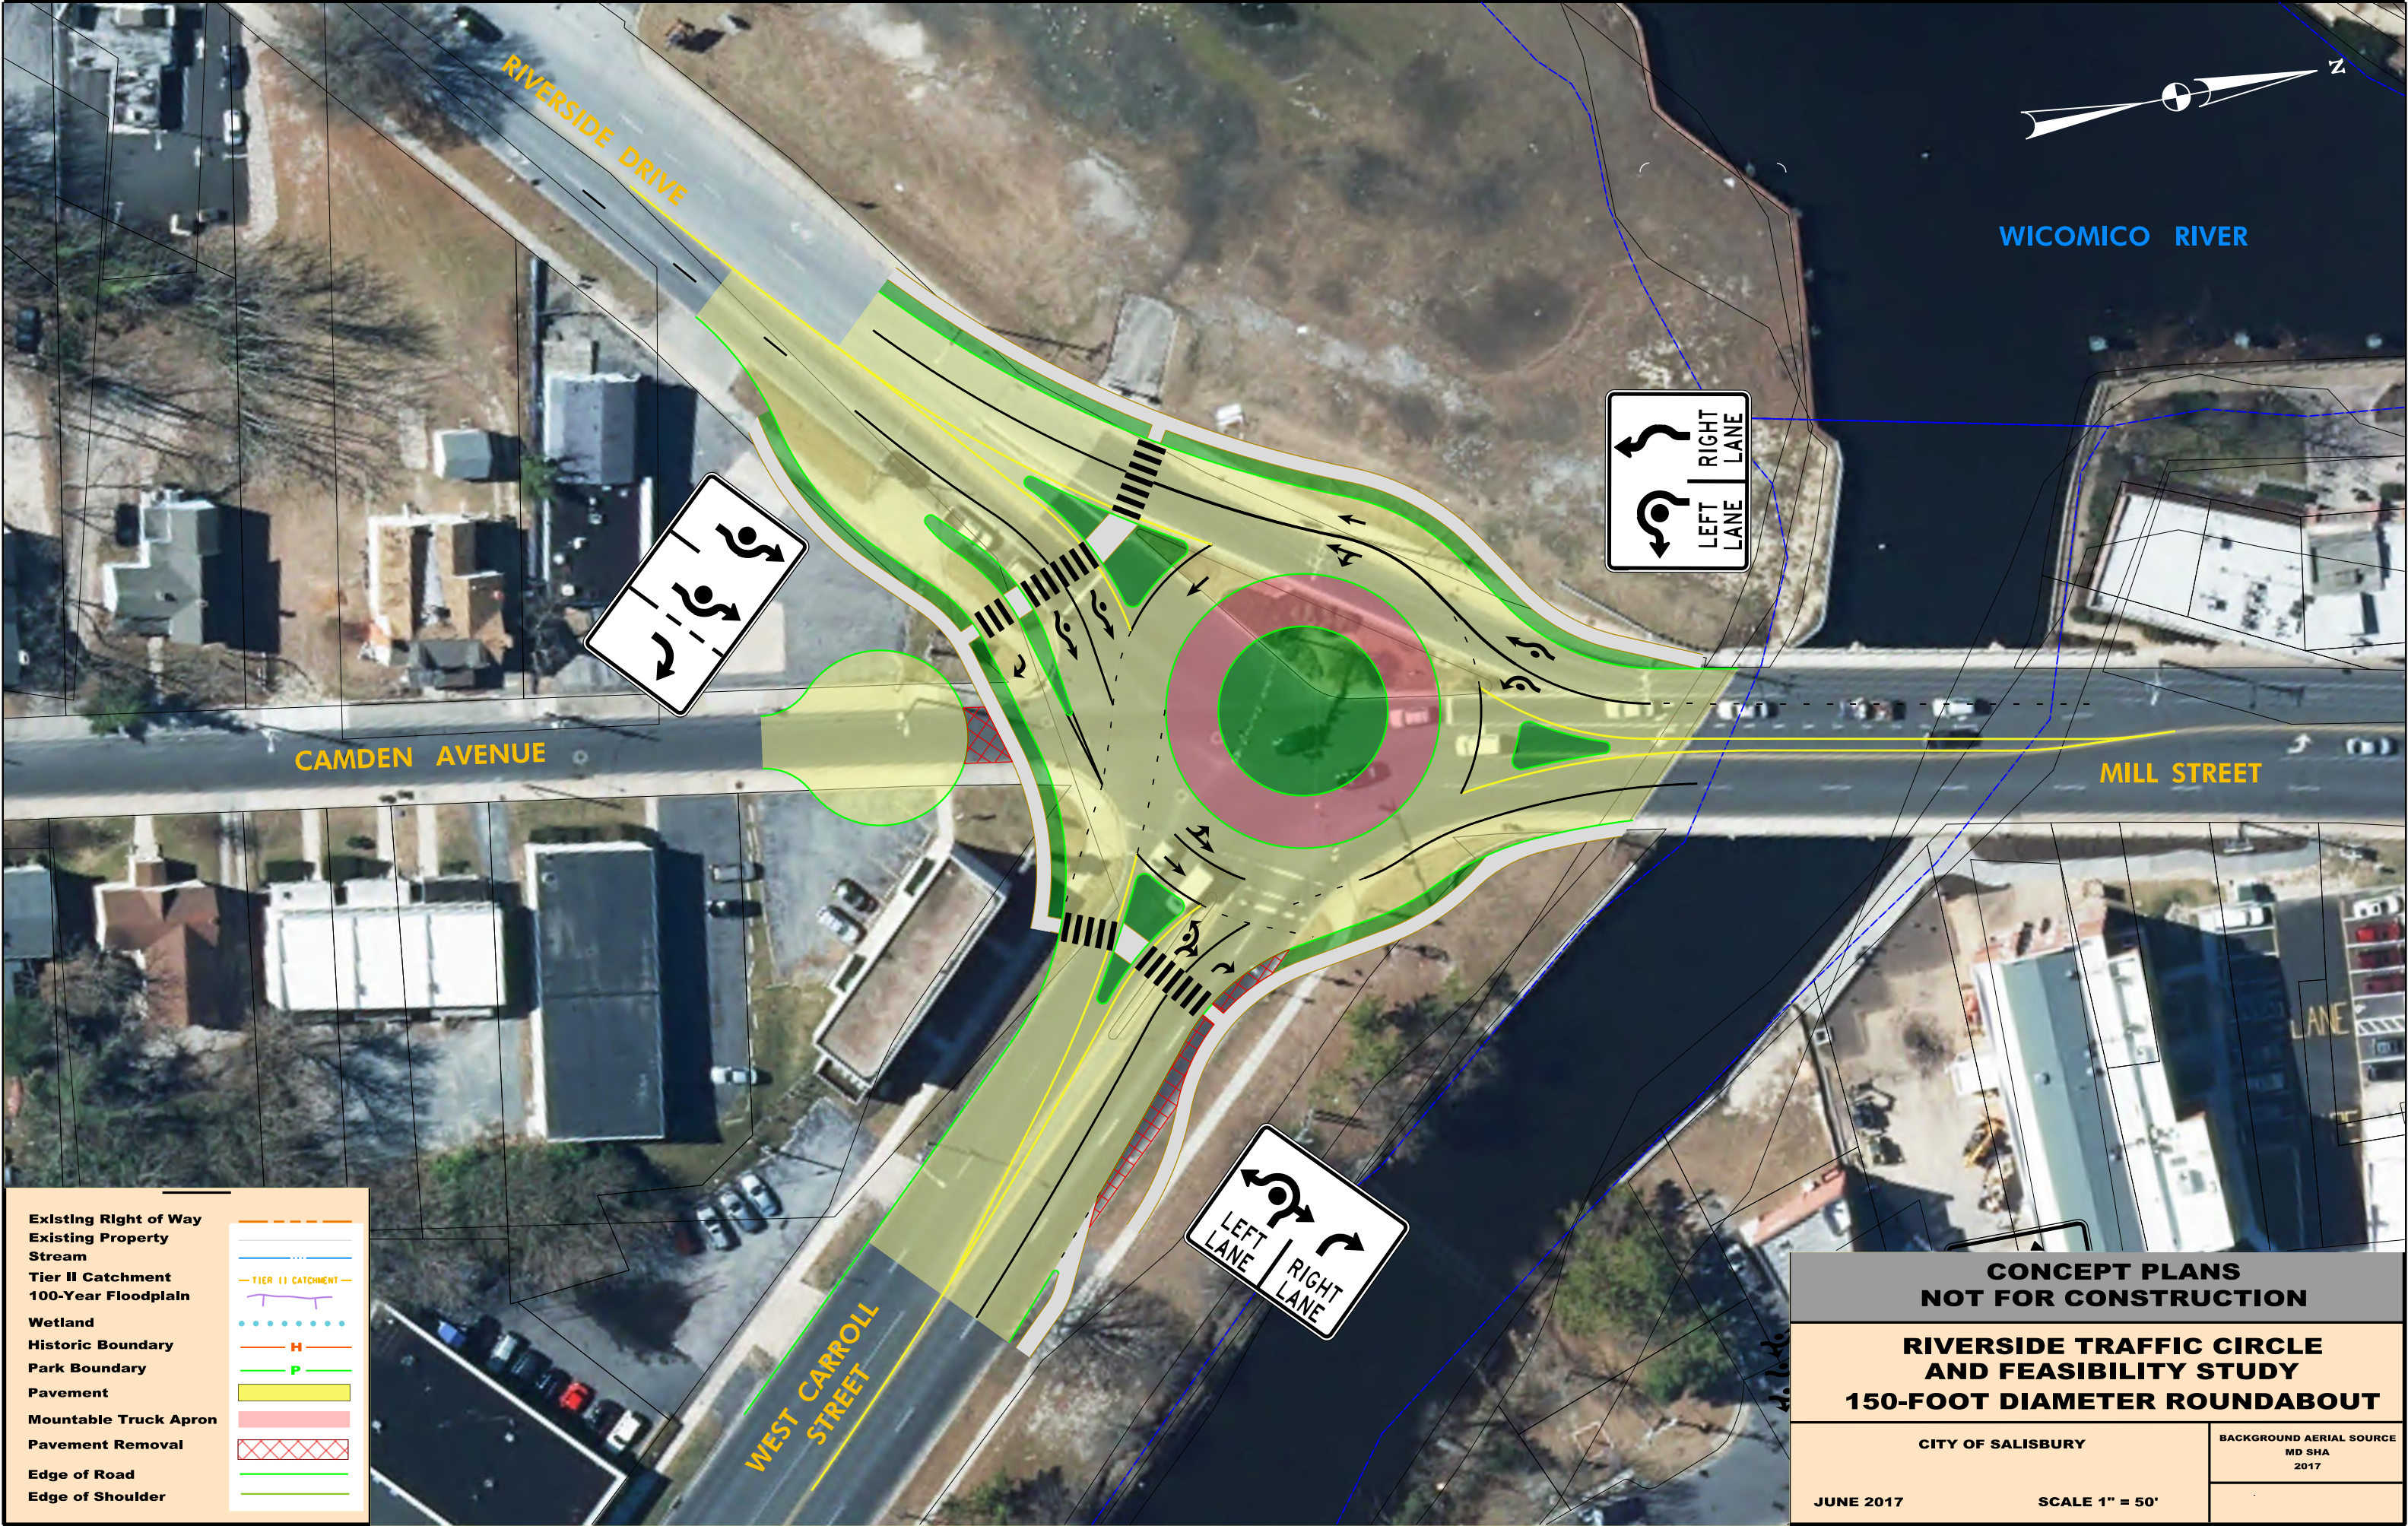
CONCEPT PLANS NOT FOR CONSTRUCTION	
RIVERSIDE TRAFFIC CIRCLE AND FEASIBILITY STUDY 150-FOOT DIAMETER ROUNDABOUT	
CITY OF SALISBURY	BACKGROUND AERIAL SOURCE MD SHA 2017
JUNE 2017	SCALE 1" = 50'

This concept proposes a multi-lane roundabout of 150-foot inscribed diameter to replace the current signalized intersection. The Camden Avenue exit would be closed and traffic redirected to Riverside Drive. Pedestrians would be accommodated at crossings over Riverside Drive, Camden Avenue, and West Carroll Street.

The roundabout would include striped bypass lanes that would direct traffic within the circumference of the roundabout but restrict any weaving with circulating traffic. The bypass lanes proposed are from Mill Street to Riverside Drive, and from Riverside Drive to West Carroll Street.

Mill Street would have two entry lanes: the left lane would direct traffic making a maneuver onto West Carroll Street, and the right lane would direct traffic into the bypass lane leading to Riverside Drive. Riverside Drive would have three entry lanes. The middle and left lanes would permit vehicles to traverse the roundabout and onto Mill Street. The rightmost lane would direct traffic onto West Carroll Street through a bypass that would permit vehicles to perform the maneuver without entering the circulatory area of the roundabout. West Carroll Street would have two entry lanes: the left lane would permit a maneuver onto Riverside Drive and Mill Street, and the right lane would exclusively direct vehicles onto Mill Street.

Closing Camden Avenue to access would be required for this configuration. An exit could not be reasonably accommodated for safety reasons, as there would be a high potential for crashes due to conflicts with the entering lanes from Riverside Drive. Closing this road would divert traffic onto Riverside Drive or West Carroll Street. It is likely that a greater percentage would use Riverside Drive. In addition, closing Camden Avenue may be advantageous for other reasons. It is generally a residential street which currently handles a significant volume of through traffic and closing this road would reduce such traffic; which may be preferred by residents. A cul-de-sac at the end of Camden Ave would need to be constructed, and the road would be changed to a two-way road between Newton Street and the cul-de-sac. No other changes would need to be made.

A preliminary analysis of the 150-foot diameter roundabout concept revealed that the intersection would operate at the level of service shown in the table below.

Further analysis using Sidra software revealed that the volume to capacity (V/C) ratio would remain acceptable for all approaches in both 2026 and 2036 although Mill Street would exhibit ratios that are near the limit for acceptability. Table 10 summarizes these results.
